Fatality #6 - March 23, 2012
Electrical - Underground - Alabama
Drummond Mining Company - Shoal Creek Mine

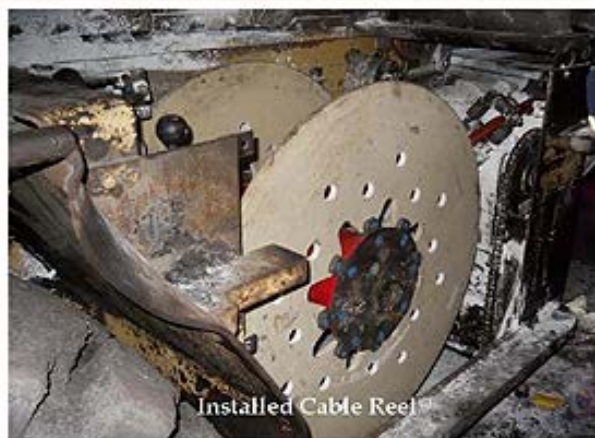
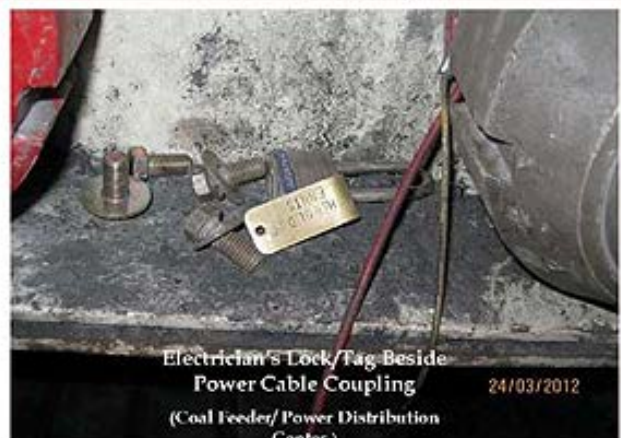
COAL MINE FATALITY - On Friday, March 23, 2012, a 37-year old electrician, with approximately 3½ years experience (approximately 1½ years as an electrician), was killed when he contacted the energized conductors of a shuttle car trailing cable. He was making the final electrical connections for a replacement cable reel when he was electrocuted.

- Develop a hazard analysis work plan before conducting repairs.
- Always lock and tag-out electrical equipment prior to electrical work.
- Perform your own lock and tag-out procedure. Never rely on others to de-energize or disconnect a circuit for you.
- Use proper Personal Protective Equipment (PPE) for all electrical work.
- Ensure that all electrical circuits and circuit breakers are identified properly before troubleshooting or performing electrical work.
- Use properly rated non-contact voltage testers to ensure that circuits are de-energized.
- Eliminate personal distractions when working on equipment.
